Compliance Inspection for State Operating Permits

Facility Name: Dowdy Pork	Tracking Number: SOPCD-0017
Permit Effective Date:	Permit Expiration Date:
Date of Inspection: June 1, 2015 Time of Inspection: 10:45 a.m.	Inspector(s) Name: Steve Owens & Crystal Warren

Facility Name: Dowdy Pork CAFO	Site Location: Somerville, TN	Tracking No.: SOPCD-0017

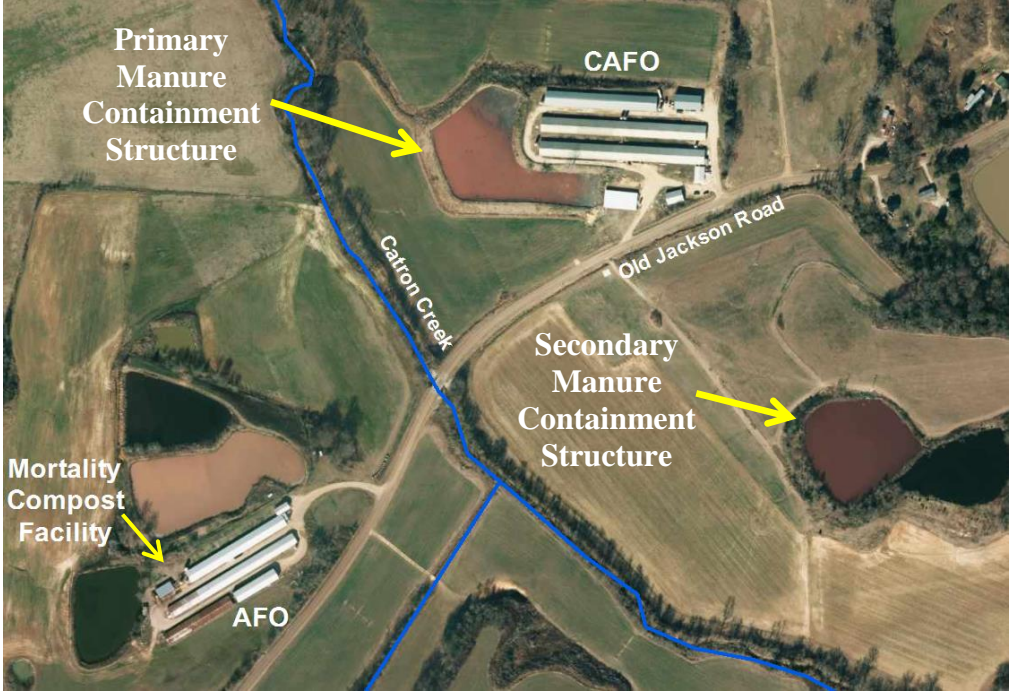
<p>An aerial photograph showing the Dowdy Pork CAFO and AFO. The CAFO is a large white building complex in the upper right. The AFO is a smaller white building complex in the lower left. A blue line representing Catron Creek runs diagonally through the center. Two yellow arrows point to the Primary Manure Containment Structure (top left) and the Secondary Manure Containment Structure (middle right). A yellow arrow also points to the Mortality Compost Facility (bottom left). Old Jackson Road is visible in the upper right.</p>		
Photo 1. Aerial photo of the Dowdy Pork CAFO, AFO, mortality compost facility and the primary and secondary manure containment structures.

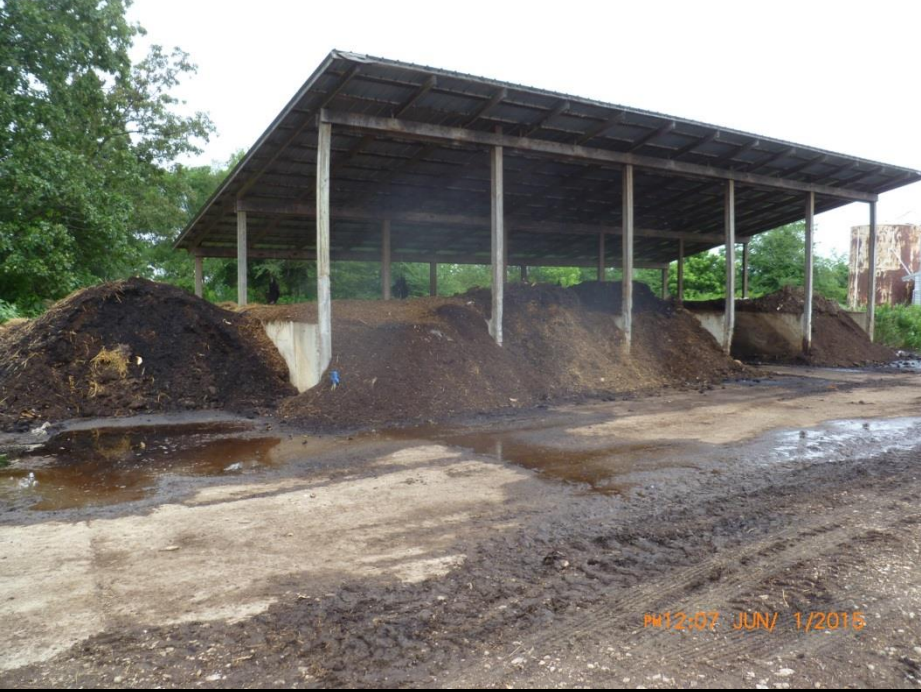
<p>A ground-level photograph of a five-bay mortality composting facility. The facility consists of a long, open-sided structure with a metal roof supported by wooden posts. Large piles of dark, composted material are visible in the bays. The ground is muddy and wet. A timestamp '06/12/07 JUN/ 1/2015' is visible in the bottom right corner.</p>		
Photo 2. Five bay mortality composting facility located on the farm south of the CAFO. Composted mortalities are used as fertilizer on adjacent crop land.

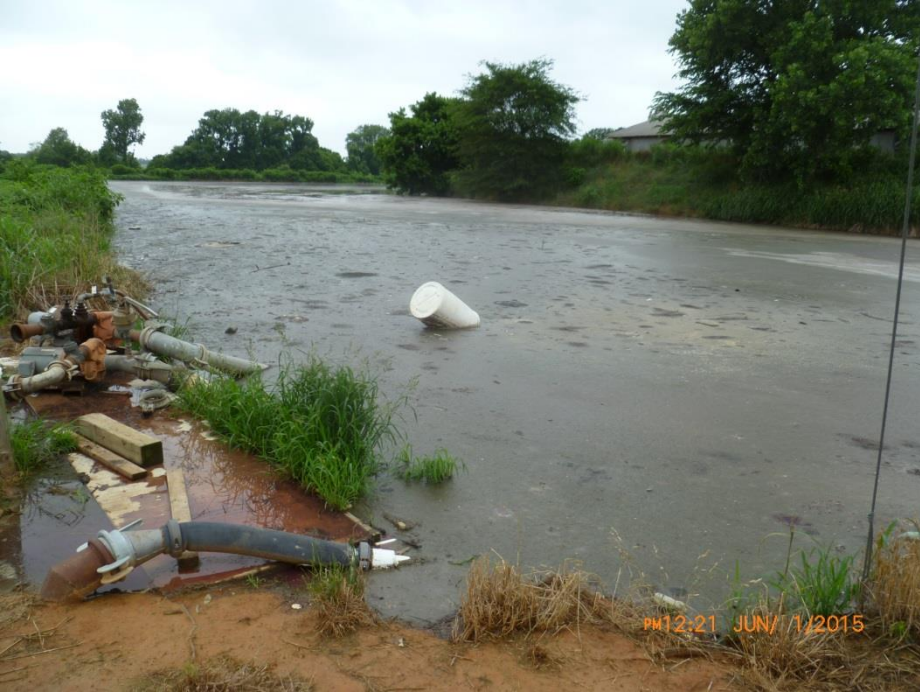
<p>Photo 3. View of the primary manure containment structure. There was very little freeboard available for additional waste from the CAFO. The depth storage marker was not visible. Mr. Dowdy stated the marker was underwater.</p>

The primary manure containment structure for the Dowdy Pork CAFO consists of a single cell lagoon located west of the barns. According to the nutrient management plan, this lagoon has a volume of approximately 632,145 ft³. A second pond located south of the CAFO across Old Jackson Road is also utilized as a secondary containment structure. The primary lagoon appeared to be at full capacity and the waste depth marker was not visible. Mr. Dowdy stated that the primary lagoon was full because he had been waiting for the intermittent precipitation events to end before beginning land application. Mortalities are managed through the use of a five bay composting facility. The compost is land applied as fertilizer.

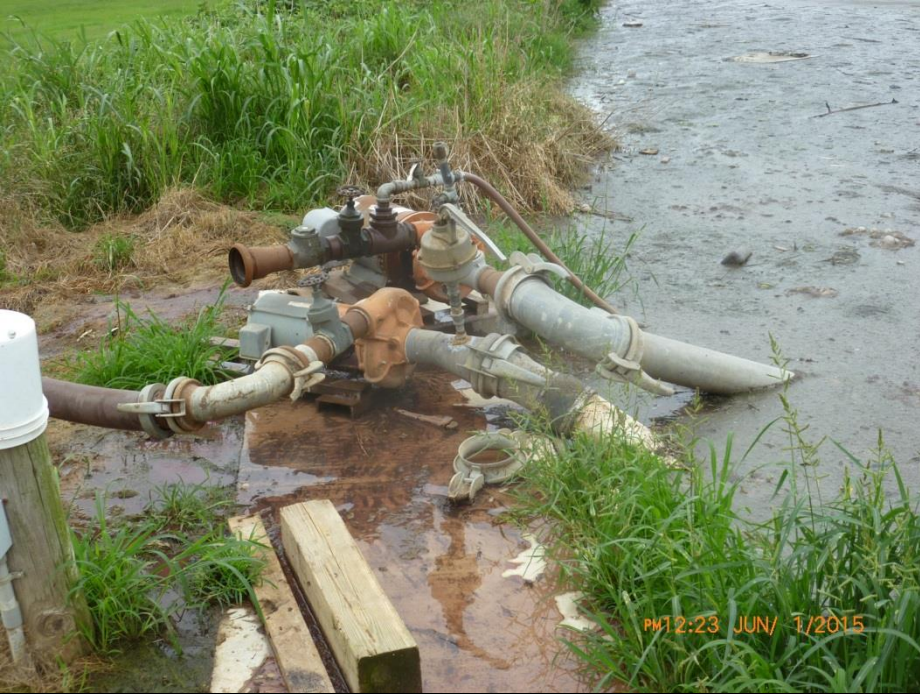
<p>Photo 4. Close-up view of the pumps shown in Photo 3. These pumps are used to either transfer manure to the secondary manure containment structure to the south or to irrigate adjacent crop fields.</p>
